Instrumentation, Field Testing, and Fatigue Evaluation of Selected Approach Spans of the Throgs Neck Bridge (TN82) over the East River, New York

Final Report

Prepared for
Parsons
TBTA

ATLSS Report No. 06-17

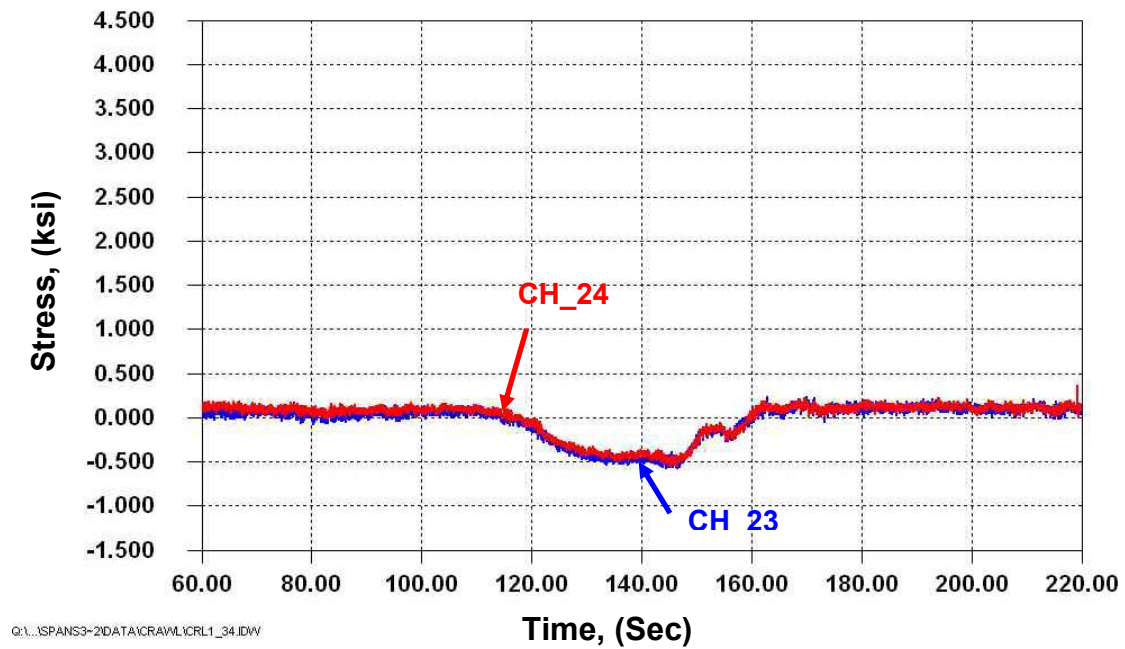
Figure 5.6 presents the response of strain gages CH_23 and CH_24 installed back-to-back on the web plate at the south cutout detail of the east shear connector located at the north end of Span 34 as Truck 1 crossed over the span in the outside lane during the controlled load test CRL1_34. The figure shows that response in both gages was identical, suggesting no out-of-plane bending behavior of the web plate of the shear connector at the instrumented location.

Figure 5.6 – Response of strain gage CH_23 and CH_24 installed back-to-back on the web plate at the south cutout detail (at a vertical distance of approximately 27 in from the top face of the top flange, and 1/4" from the cut edge) of the east shear connector located at the north end of Span 34 as Truck 1 crossed in the northbound direction over the span in the outside lane in the controlled load test CRL1_34

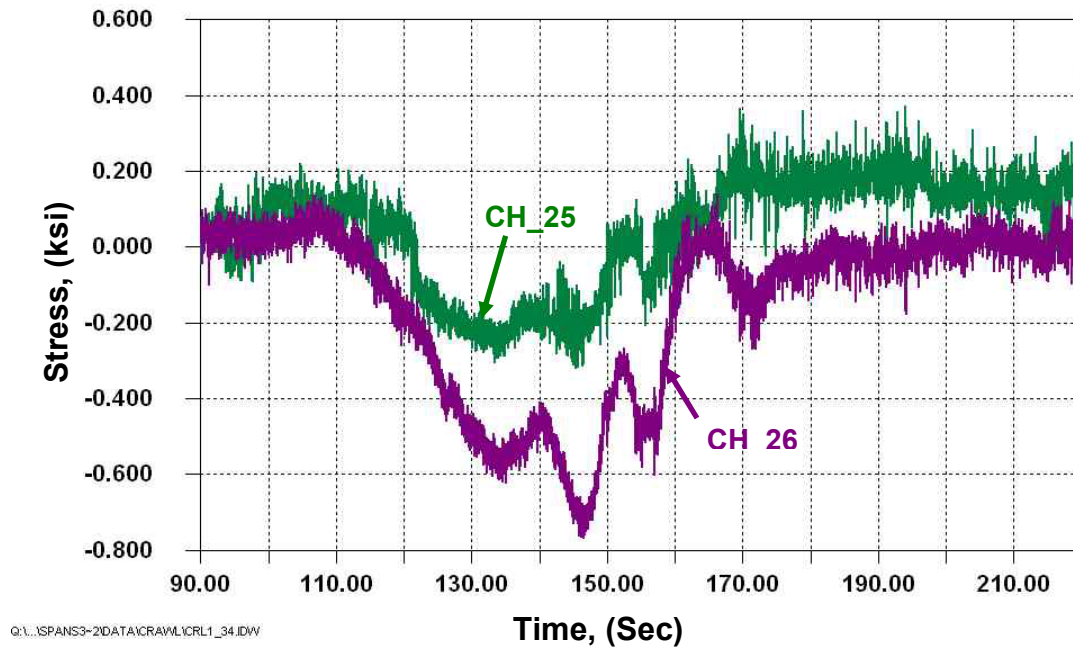
In Figure 5.7, the response of strain gage CH_25 and CH_26 installed back-to-back on the same cutout slightly below gages CH_23 and CH_24, as Truck 1 crossed over the span in the outside lane during the controlled load test CRL1_34, indicates slight localized response, suggesting that shear connector web plate experience small localized out-of-plane bending stresses along with the in-plane stresses at the instrumented location.

Figure 5.7 – Response of strain gage CH_25 and CH_26 installed back-to-back on the web plate at the south cutout detail (below strain gage CH_23 and CH_24, at a vertical distance of approximately 20 1/2" from the top face of the top flange, and 1/4" from the cut edge) of the east shear connector located at the north end of the span as Truck 1 crossed in the northbound direction over Span 34 in the outside lane in the controlled load test CRL1_34

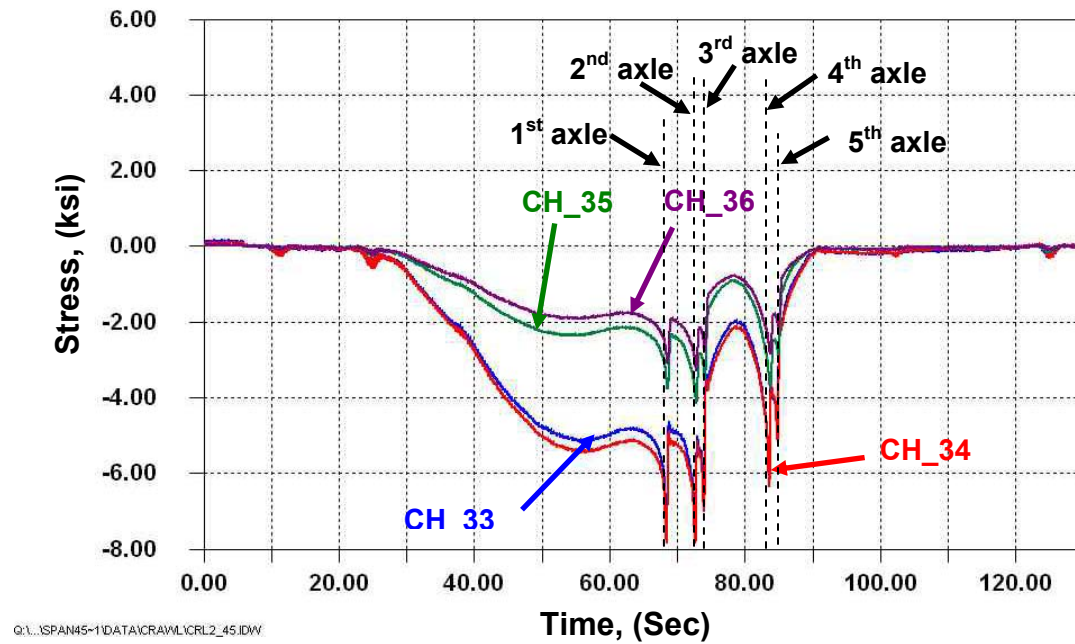
The localized response in the shear connector can be seen clearly in Figure 5.8, which shows the time history response of strain gages CH_33, CH_34, CH_35, and CH_36 as Truck 1 and Truck 2 traveled side-by-side in the outside and middle lane, respectively. The presence of the Truck 2 in the middle lane appears to have a major effect on the response of the detail. Summaries of the maximum stress, minimum stress, and stress range values experienced by the gages in the crawl tests, including the multiple presence truck test are listed in Tables 5.15 through 5.18.

Figure 5.8 – Response of strain gages CH_33, CH_34, CH_35, and CH_36 installed on the web plate at the south cutout detail on the east shear connector located at the north end of Span 45 as Truck 1 and Truck 2 crossed side-by-side in the northbound direction over the span in the outside and middle lane during the controlled load test CRL2_45

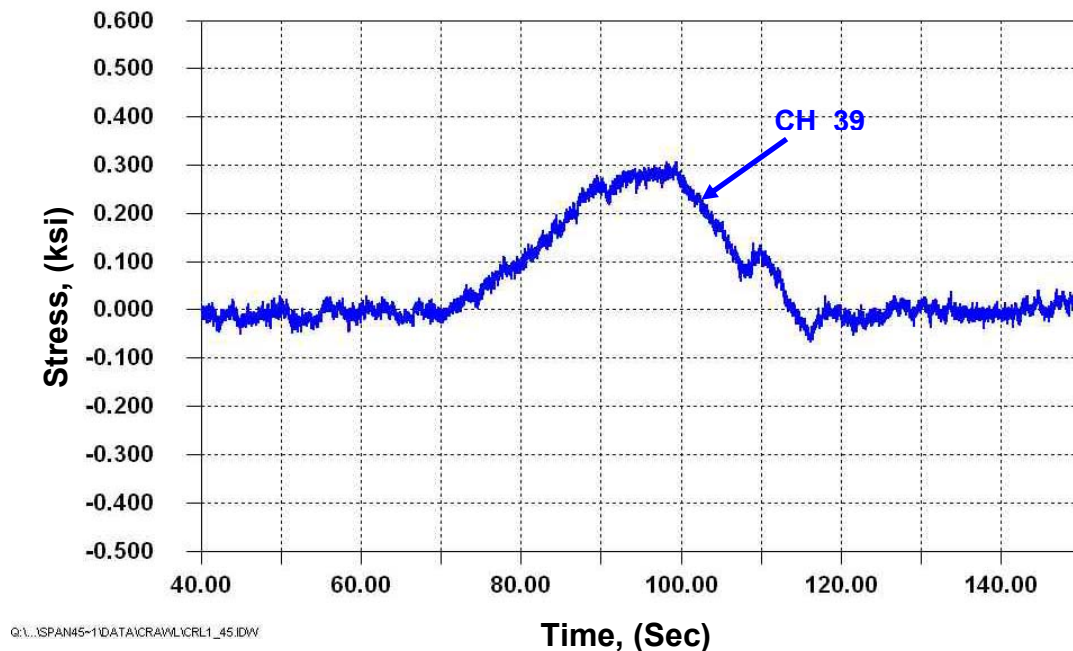
As previously discussed, strain gage CH_39 was installed on the web plate of the east shear connector located at the north end of Span 45. The gage was installed near the north end of the plate and longitudinally along the longitudinal weld used for attaching the shear connector to the bottom face of the deck steel plate in Span 45. The response of the strain gage to the crossing of Truck 1 in the outside lane over the span in the northbound direction in the controlled load test CRL1_45 is shown in Figure 5.9. The figure shows low response measured by the strain gage during the crossing of Truck 1 in the outside lane. The response of the strain gage to the passage of the test truck(s) in all crawl tests was low as indicated in Table 5.19.

Figure 5.9 – Response of strain gage CH_39 installed on the web plate of the east shear connector located at the north end of Span 45 near the north end of the plate and longitudinally along the longitudinal weld used for attaching the shear connector to the bottom face of the deck steel plate in Span 45 as Truck 1 crossed in the northbound direction over the span in the outside lane during the controlled load test CRL1_45.

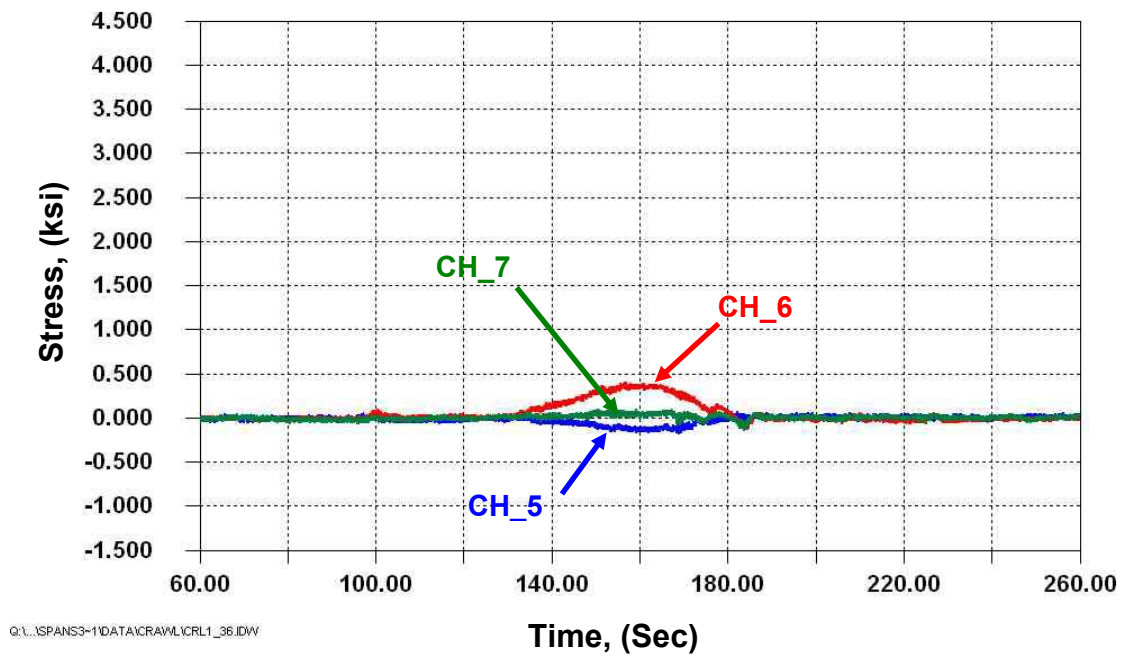
The response of strain gages CH_5, CH_6, and CH_7 during the passage of Truck 1 over Span 36 in the outside lane in the northbound direction in the controlled load test CRL1_36 is shown in Figure 5.10. As shown in the figure, low response was measured by the gages during the passage of the test truck. In fact, the response of all gages installed on the shear connector web plate near the bolted stiffener element is low as indicated in Table 5.20 through Table 5.23.

Figure 5.10 – Response of strain gages CH_5, CH_6 and CH_7 installed against the vertical angle element of the shear connector on the north shear connector, at the north end of the span over the east girder and on the west face of the shear connector plate in Span 36 as Truck 1 crossed in the northbound direction over the span in the outside lane during the controlled load test CRL1_36

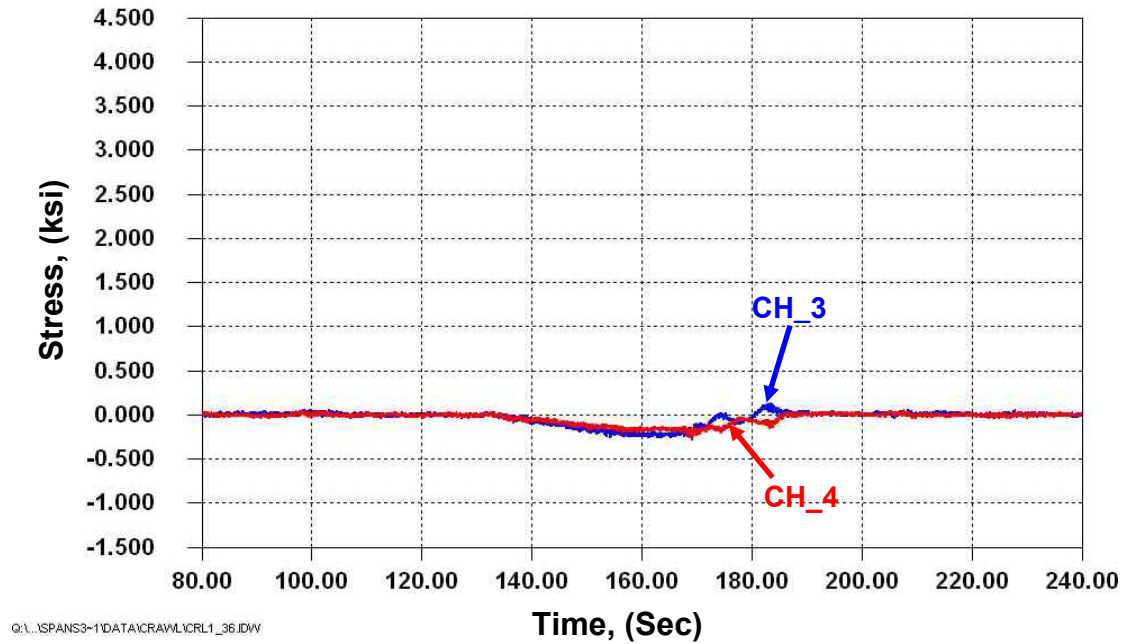
Figure 5.10 presents the response of strain gages CH_3 and CH_4 installed back-to-back on the outstanding leg of the north end stiffener angle bolted to the web of the shear connector at the north end of the span over the east girder as Truck 1 crossed over the span in the outside lane during the controlled load test CRL1_36. Except for the last portion of the curve (time 170 sec to time 185 sec), Figure 5.10 shows that the magnitude of the response in both gages was almost the same indicating the in-plane bending was the dominate response of both gages. Opposite sign in the response of the gages in the last portion of the curve indicates out-of-plane bending of the vertical stiffener.

Figure 5.10 – Response of strain gages CH_3 and CH_4 installed back-to-back on the outstanding leg of the north end stiffener angle (at mid height of the stiffener and mid width of the outstanding leg) bolted to the web of the shear connector at the north end of the span over the east girder as Truck 1 crossed in the northbound direction over the span in the outside lane during the controlled load test CRL1_36.

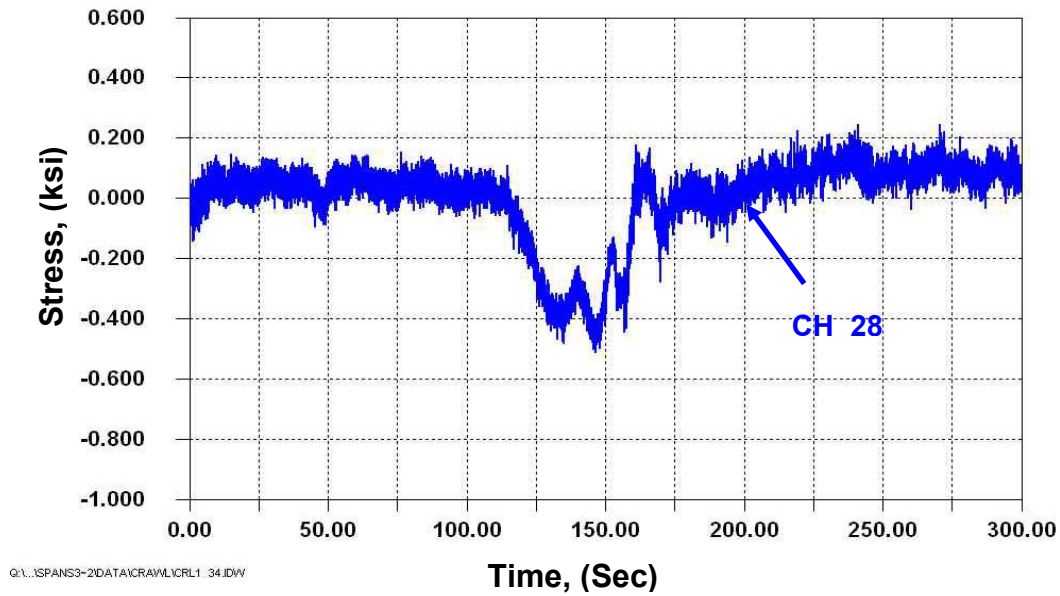
Strain gages CH_28, CH_29, CH_32 and CH_37 are classified as Category C detail per AASHTO Specifications with CAFL of 10 ksi. The response of strain gage CH_28 installed transversely on the bottom face of the deck plate at 2 in off-center from the shear connector web as Truck 1 crossed over Span 34 in the controlled load test CRL1_34 is shown in Figure 5.11. Figure 5.12 shows the response of strain gage CH_29 installed longitudinally on the bottom face of the deck plate at 1 1/2" from the termination of the longitudinal shear connector weld as Truck 1 crossed over Span 34 in the controlled load test CRL1_34.

Figure 5.11 – Response of strain gage CH_28 installed transversely on the bottom face of the deck plate at 2 in off-center from the shear connector web in Span 34 as Truck 1 crossed in the northbound direction over the span in the outside lane in the controlled load test CRL1_34

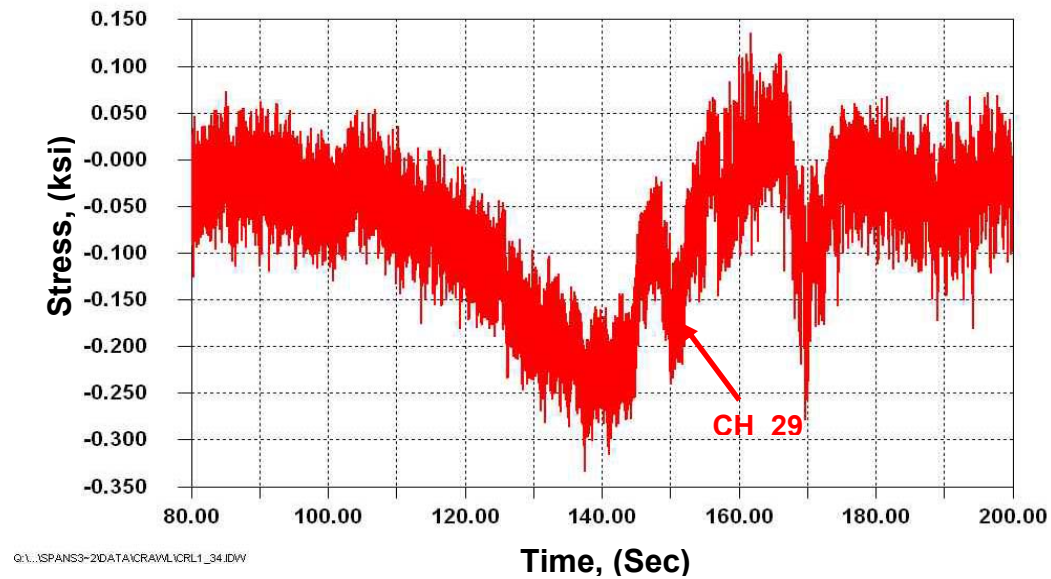
Figure 5.12 – Response of strain gage CH_29 installed longitudinally on the bottom face of the deck plate at 1 1/2" from the termination of the longitudinal shear connector weld in Span 34 as Truck 1 crossed in the northbound direction over the span in the outside lane in the controlled load test CRL1_34

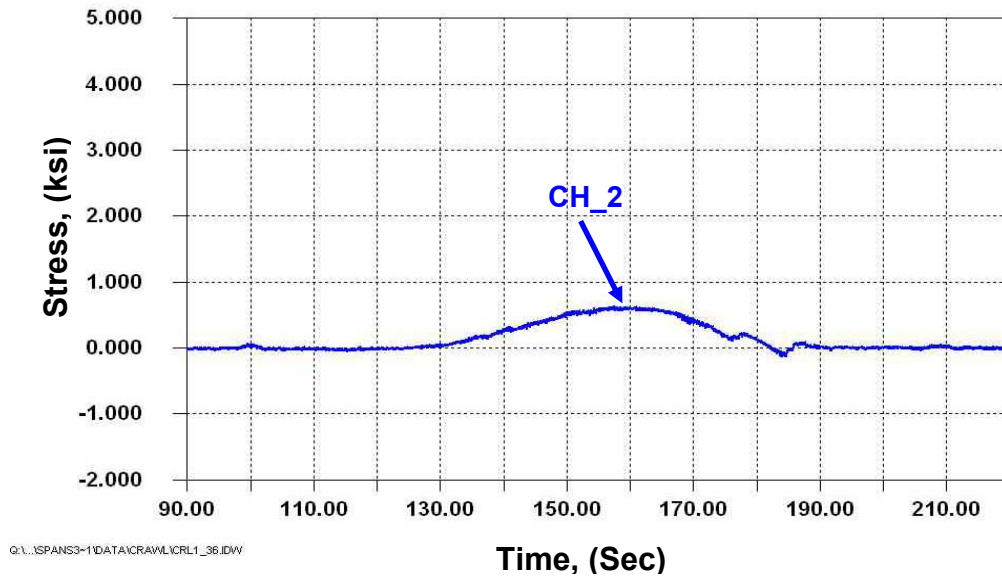
The detail where strain gage CH_2 was installed is classified as Category C detail per AASHTO Specifications. The response of CH_2 to the crossing of Truck 1 in the outside lane in controlled load test CRL1_36 is shown in Figure 5.13. As the figure shows, low response was measured during the crossing of the truck. However, when the transverse position of the test truck was changed (i.e., Truck 3 in the middle lane instead of Truck 1 in the outside lane), the response measured by the strain gage was significantly higher as shown in Figure 5.14. The figure also shows the effect of the transverse position of the truck on the response as each axle of the truck produced a stress cycle.

Figure 5.13 – Response of strain gage CH_2 installed on the bottom face of the deck plate at the north end termination of the north shear connector located above the east girder in Span 36 as Truck 1 crossed in the northbound direction over the span in the outside lane in the controlled load test CRL1_36

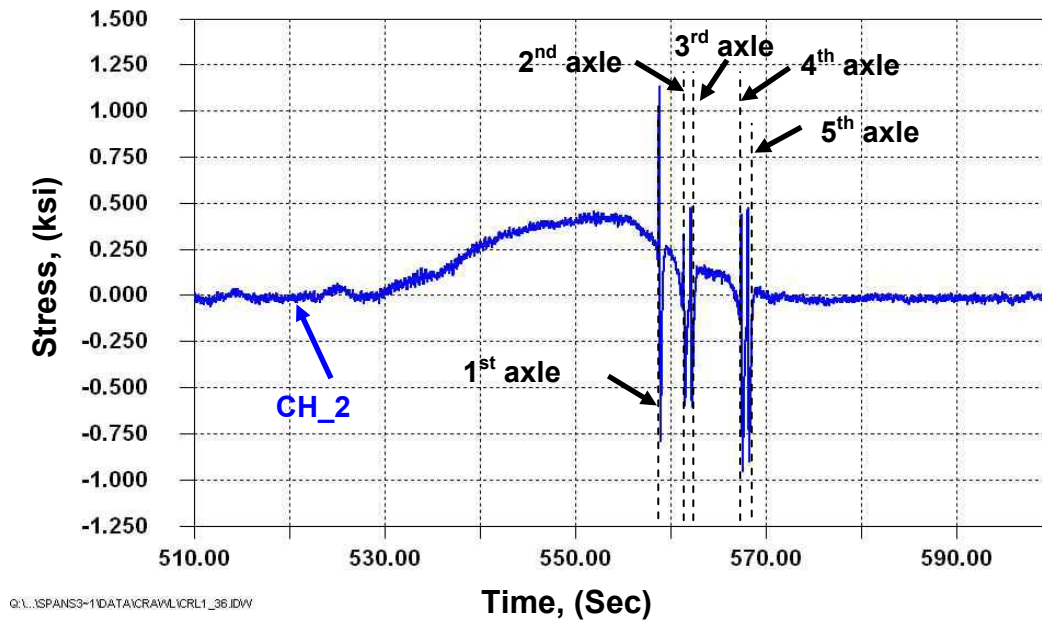
Figure 5.14 – Response of strain gage CH_2 installed on the bottom face of the deck plate at the north end termination of the north shear connector located above the east girder in Span 36 as Truck 3 crossed in the northbound direction over the span in the outside lane in the controlled load test CRL1_36

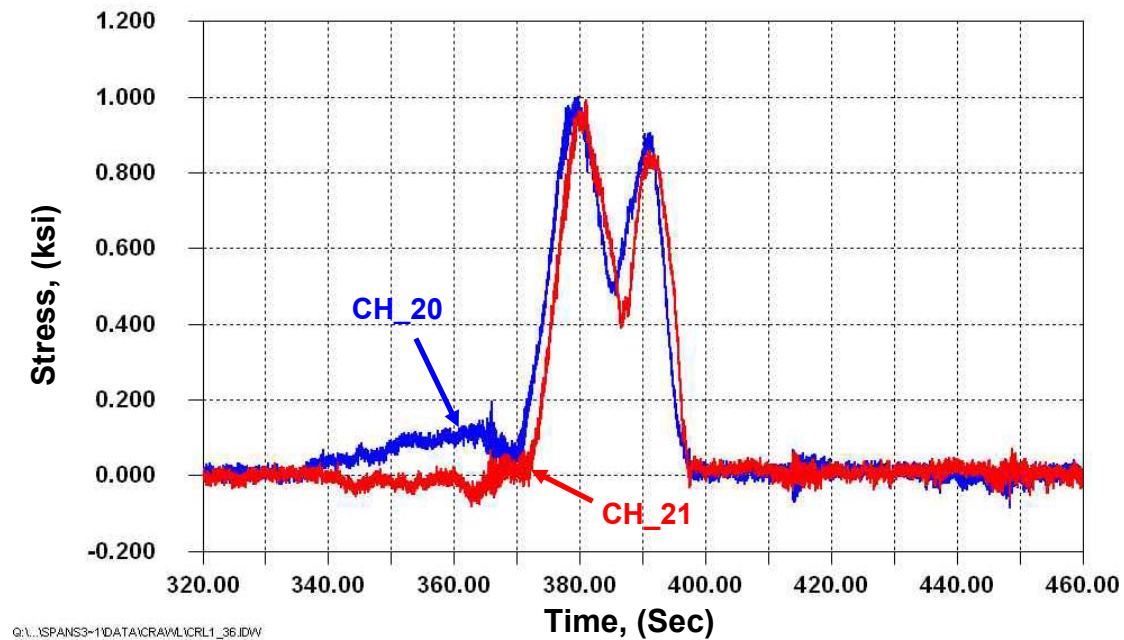
The top flange welded detail can be classified as Category C detail per AASHTO Specifications, while the bottom flange bolted cover plate detail can be classified as Category B detail. The responses of strain gages CH_20 and CH_21 installed in Span 36 on the top flange of the new Sub-floorbeam 8 and strain gages CH_24 and CH_25 installed on the bottom flange of the same sub-floorbeam are shown in Figure 5.16 and Figure 5.17, respectively. As shown in the figures and as expected, tensile stresses were recorded by the gages installed on the top flange of the new sub-floorbeam and compressive stresses were recorded by the gages installed on the bottom flange of the same new-sub-floorbeam, indicating the sub-floorbeam is in negative bending.

Figure 5.16 – Response of strain gages CH_20 and CH_21 installed on the top flange (T-section web) of the new Sub-floorbeam 8 west of the web of Stringer 3 and near the south and north end, respectively, of the flange edge at 1 in from the toe of the weld used for attaching the web and the flange of the T-section and at 1 in from the edge of the reduced section of the flange in Span 36 as Truck 2 crossed in the northbound direction over the span in the controlled load test CRL1_36

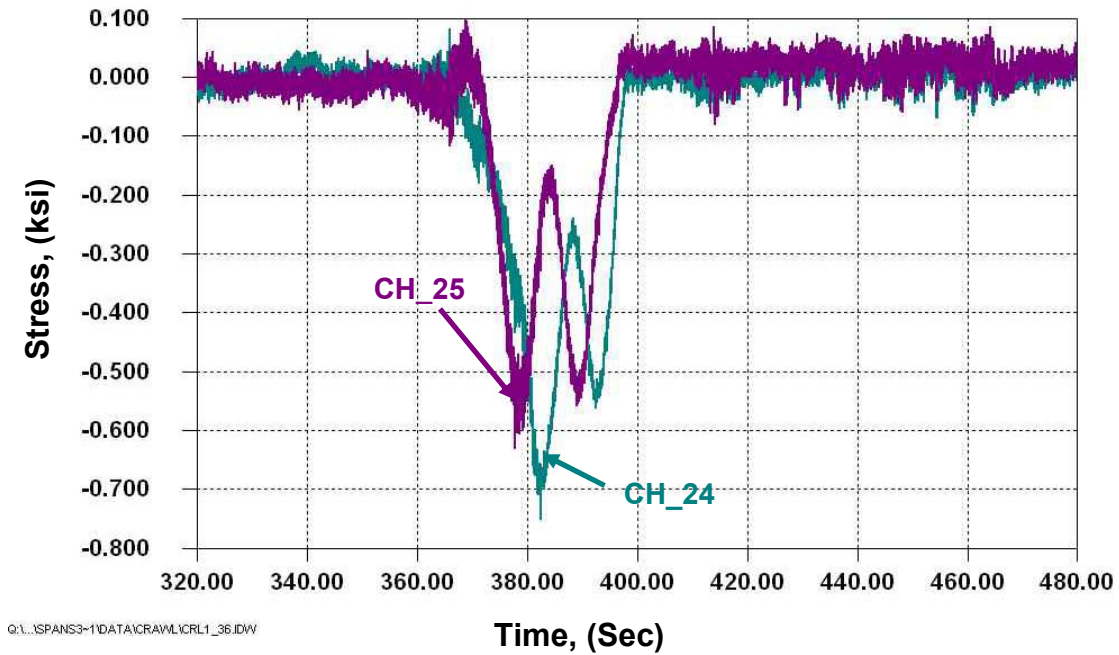
Figure 5.17 – Response of strain gages CH_24 and CH_25 installed on the bottom cover plate bolted to the bottom flange of new Sub-floorbeam 8 near the south and north edge, respectively, of the cover plate in Span 36 as Truck 2 crossed in the northbound direction over the span in the controlled load test CRL1_36

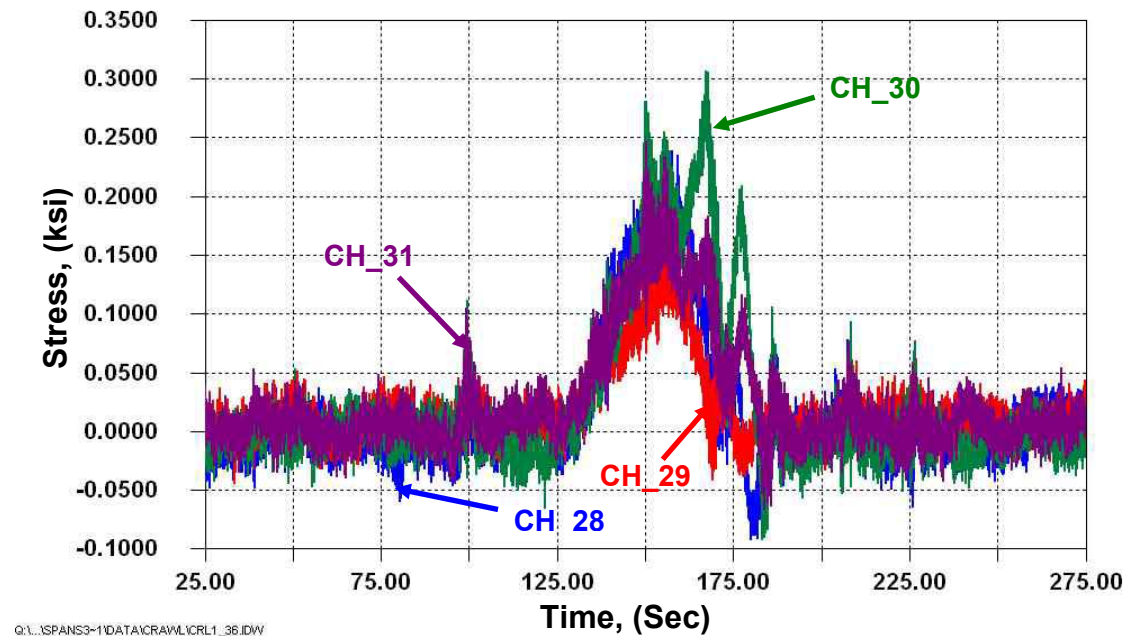
Figure 5.18 shows the response of strain gages CH_28, CH_30, CH_29, and CH_31 installed in Span 36 on the east and west web plate of Rib 6 during the crossing of Truck 1 in the outside lane over the span in the crawl test CRL1_36. The figure shows small difference in the response in all four gages with slightly higher response measured by strain gage CH_30. The response in the gages increased as the test truck crossed directly over the gages. This can be seen in Figure 5.19, which shows the response of all four gages to the crossing of Truck 4 in the middle lane during crawl test CRL1_36. Figure 5.20 shows the response CH_50, CH_52, CH_51, and CH_53 installed in Span 35 on the east and west web plate of Rib 6 as mentioned above during the crossing of Truck 4 in the middle lane over the span in the crawl test CRL1_34. A comparison between the response of the strain gages installed in Span 35 and those installed in Span 36 in comparable locations show that the retrofit scheme installed in Span 36 at the instrumented location (i.e., installation of keeper blocks, etc.) could have resulted in a decreased magnitude of the stress range measured by strain gages CH_29 and CH_31 compared to strain gages CH_52 and CH_53, respectively, installed in Span 35. On the other hand, the figure also shows an increase in the magnitude of the stress range measured by strain gages CH_28 and CH_30 installed in Span 36 compared to strain gages CH_50 and CH_51, respectively, installed in Span 35, which could be caused by the retrofit. It is important to note that the increase in the stress cycle may result in

fatigue crack growth from the weld root, instead of the weld toe, considering the residual stresses in the weld and the increased stress on the weld throat.

Figure 5.18 – Response of strain gages CH_28, CH_29, CH_30, and CH_31 installed in Span 36 on the east and west web plate of Rib 6 as Truck 1 crossed in the northbound direction over the span in the outside lane during the controlled load test CRL1_36

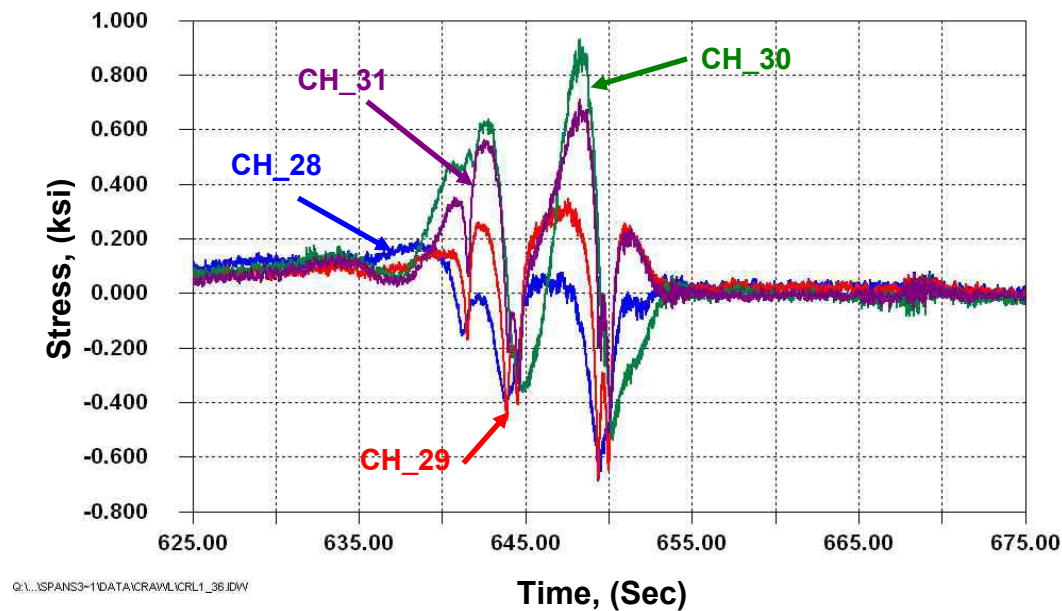
Figure 5.19 – Response of strain gages CH_28, CH_29, CH_30, and CH_31 installed in Span 36 on the east and west web plate of Rib 6 as Truck 4 crossed in the northbound direction over the span in the middle lane during the controlled load test CRL1_36

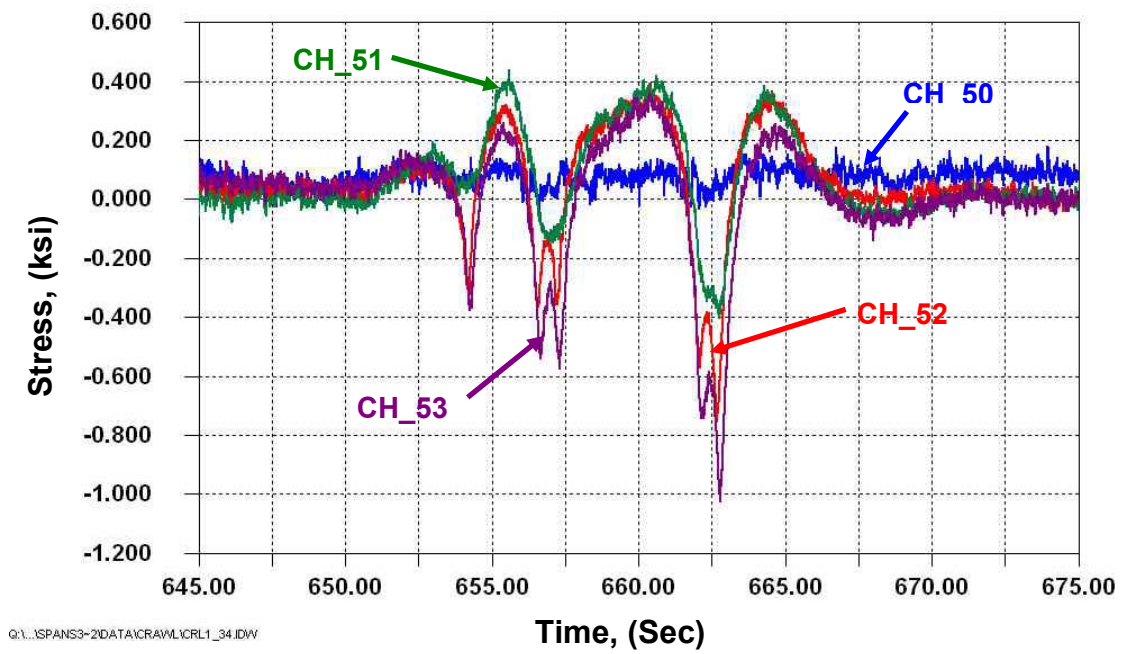
Figure 5.20 – Response of strain gages CH_50, CH_51, CH_52, and CH_53 installed in Span 35 on the east and west web plate of Rib 6 as Truck 4 crossed in the northbound direction over the span in the middle lane during the controlled load test CRL1_34

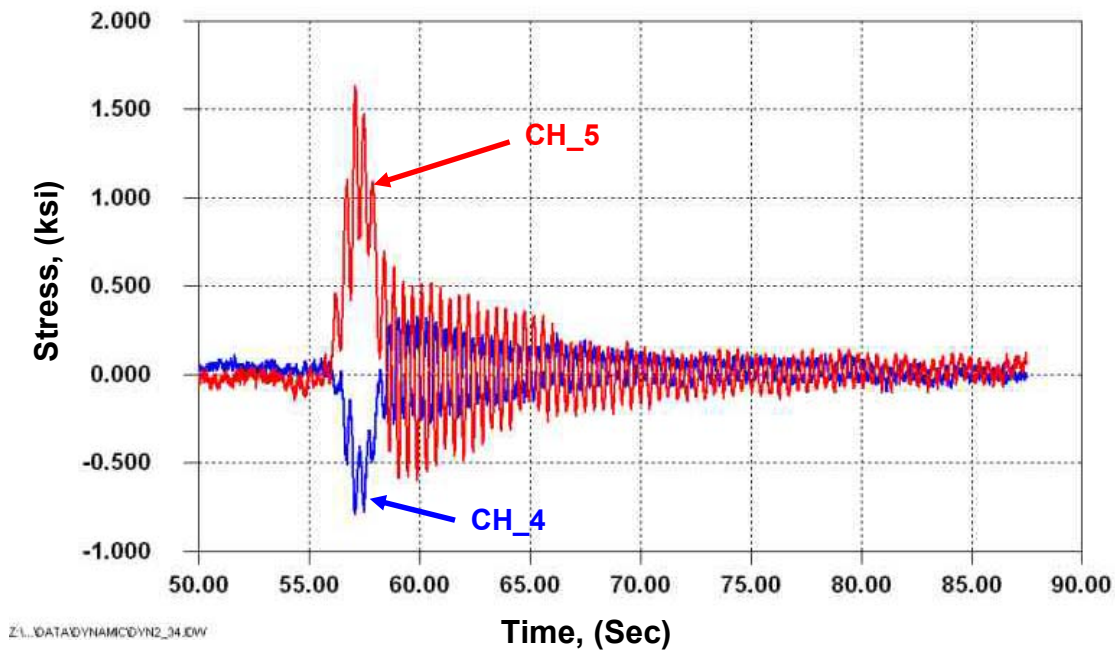
Figure 5.21 – Response of strain gage CH_4 & CH_5 installed on the top and bottom flange, respectively, of the east girder in Span 34, approximately 4 in north of midspan as Truck 2 crossed in the northbound direction in the outside lane during test DYN1_34

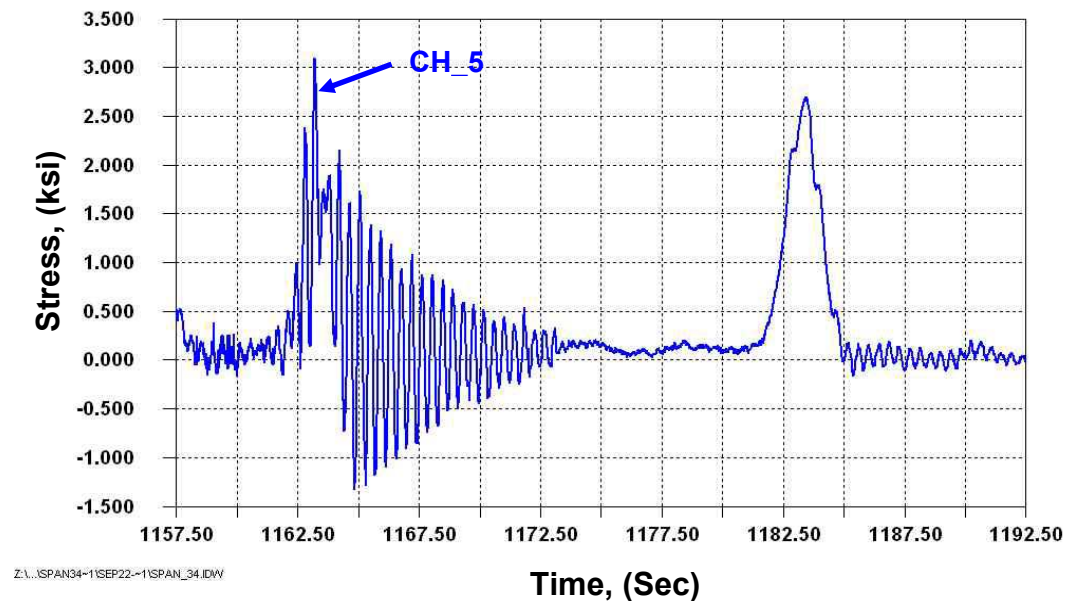
During the monitoring period it was observed, when viewing the data, that the vibration of the girder is rather random. Figure 6.1 is an example of the response of strain gages CH_5 during two triggered time-history events. As shown in the figure, the magnitude of the peak response in both events is very similar (i.e., 3.0 ksi in the first event and 2.7 ksi in the second event). However, in the first event, the girder underwent excessive vibration, while no vibration was observed in the second event. Such observation is not consistent with the results of the dynamic controlled load tests as dynamic vibration of the girder was observed during each dynamic test. This could be due to the orthotropic deck system being light in weight such that its interaction with vehicles crossing the bridge is always varying (depending on vehicle type, suspension system of the vehicle, etc.). The excessive vibration of the girder during the random monitoring could result in a dynamic amplification factor of the girder being higher than what is observed during the controlled load test.

Figure 6.1 – Random time-history response of strain gage CH_5 installed on the bottom flange of the east girder in Span 34, approximately 4 in north of midspan

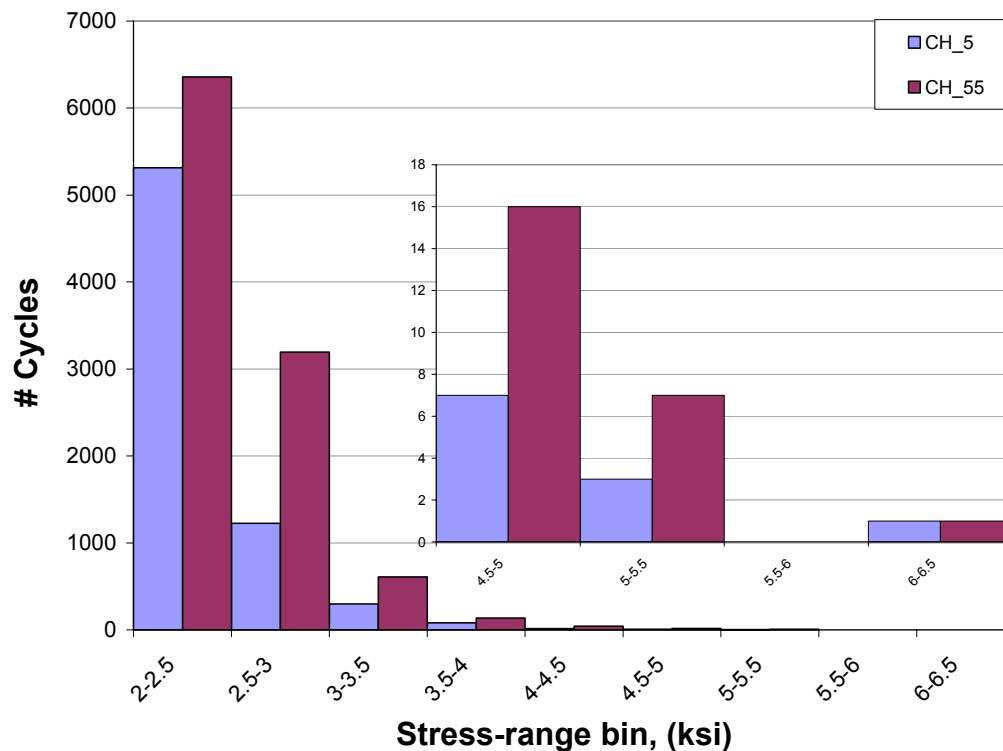
The detail is classified as Category D detail per AASHTO Specifications with a constant amplitude fatigue limit (CAFL) of 7 ksi. No stress-range cycles higher than the CAFL of the detail were measured at any of the instrumented locations during the monitoring period. The highest magnitude of stress range measured was 6.3 ksi and was recorded by strain gages CH_5 and CH_55 installed on the bottom flange of the east girder in Span 34 and Span 35, respectively. Figure 6.2 shows the stress-range histogram for strain gage CH_5 and strain gage CH_55. The inset in the figure is a magnification of the right-most portion of the histogram. The histogram was produced using a lower-bound stress range truncation level of 1.75 ksi, which is approximately 1/4 of the CAFL of the detail. More detailed discussion on truncation levels used in fatigue evaluations can be found in Appendix B. A summary of the magnitude of the maximum stress range, effective stress range, number of cycles measured per day, and the estimated remaining fatigue life for the instrumented details is presented in Table 6.1. As can be seen in the table, the fatigue life calculations indicate an infinite remaining life for all four instrumented east riveted girders details.

Figure 6.2– Stress-range histogram for strain gages CH_5 and CH_55 installed on the bottom flange of the east girder in Span 34 and Span 35, respectively, at 4 ft north of mid span

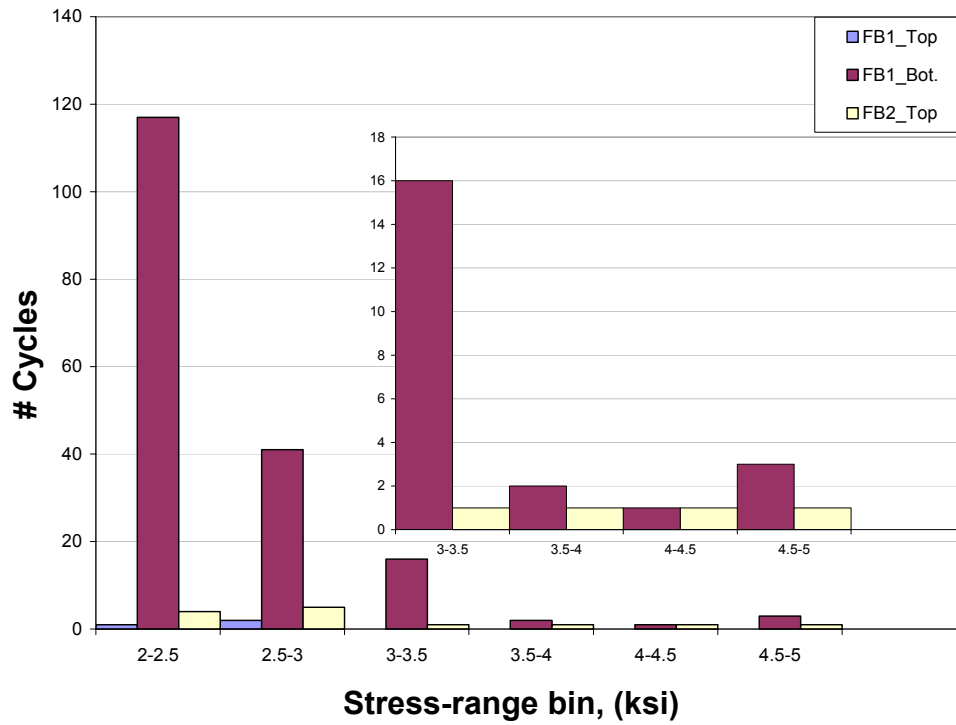
The detail is classified as Category D detail per the AASHTO Specifications with a CAFL of 7 ksi. Figure 6.2 presents the stress-range histogram for strain gage FB1_Top and FB1_Bot. installed on the top and bottom flange, respectively, of Floorbeam 1 at 9ft-1 in west of mid span of the floorbeam and FB2_Top installed on the top flange of Floorbeam 2 at mid span of the floorbeam. As shown in the figure, no stress-range cycles higher than the CAFL of the detail were measured. The inset in the figure shows the highest stress-range cycles measured during the long-term monitoring to be 4.75 in strain gages FB1_Top and FB2_Bot. The histogram was produced using a lower-bound stress range truncation level of 1.75 ksi, which is approximately 1/4 of the CAFL of the detail. A summary of the fatigue life calculations is presented in Table 6.2. As shown in the table, infinite fatigue life is estimated for the floorbeam riveted flange detail. Strain gage FB2_Bot. was observed to be unstable during the long-term monitoring and was therefore not used to estimate the remaining fatigue life of the detail.

Figure 6.2 – Stress-range histogram for strain gages FB1_Top, FB1_Bot., installed on the top and bottom flange, respectively, of Floorbeam 1 at 9ft-1 in west of mid span of the floorbeam and strain gage FB2_Top installed on the top flange of Floorbeam 2 at mid span of the floorbeam.

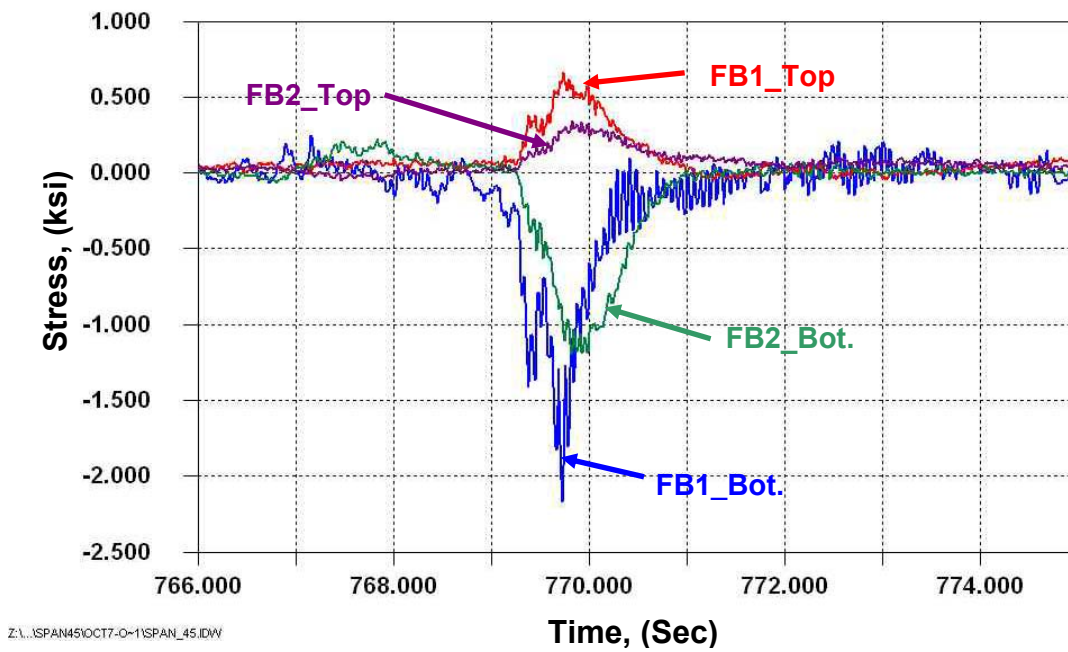
The relative magnitude of the stresses measured by strain gage FB2_Bot. with respect to the stresses measured by the other strain gages installed on Floorbeam 1 and Floorbeam 2 can be seen in Figure 6.3. The figure shows a typical response of the four strain gages (FB1_top, FB1_Bot., FB2_Top, and FB2_Bot.). It is important to note that the collected time-history response data of the gages showed that, in some events, the gages installed on the top flange of the floorbeams experience tensile stresses while the gages installed on the bottom flange of the floorbeams experienced compressive stresses (Figure 6.3). This could be due to a particular transverse configuration of the vehicles crossing on the bridge over the floorbeams, which could have forced the floorbeams to experience double curvature.

Figure 6.3 – Response of strain gage strain gages FB1_Top, FB1_Bot., installed on the top and bottom flange, respectively, of Floorbeam 1 at 9ft-1 in west of mid span of the floorbeam and strain gages FB2_Top and FB2_Bot. installed on the top flange of Floorbeam 2 at mid span of the floorbeam

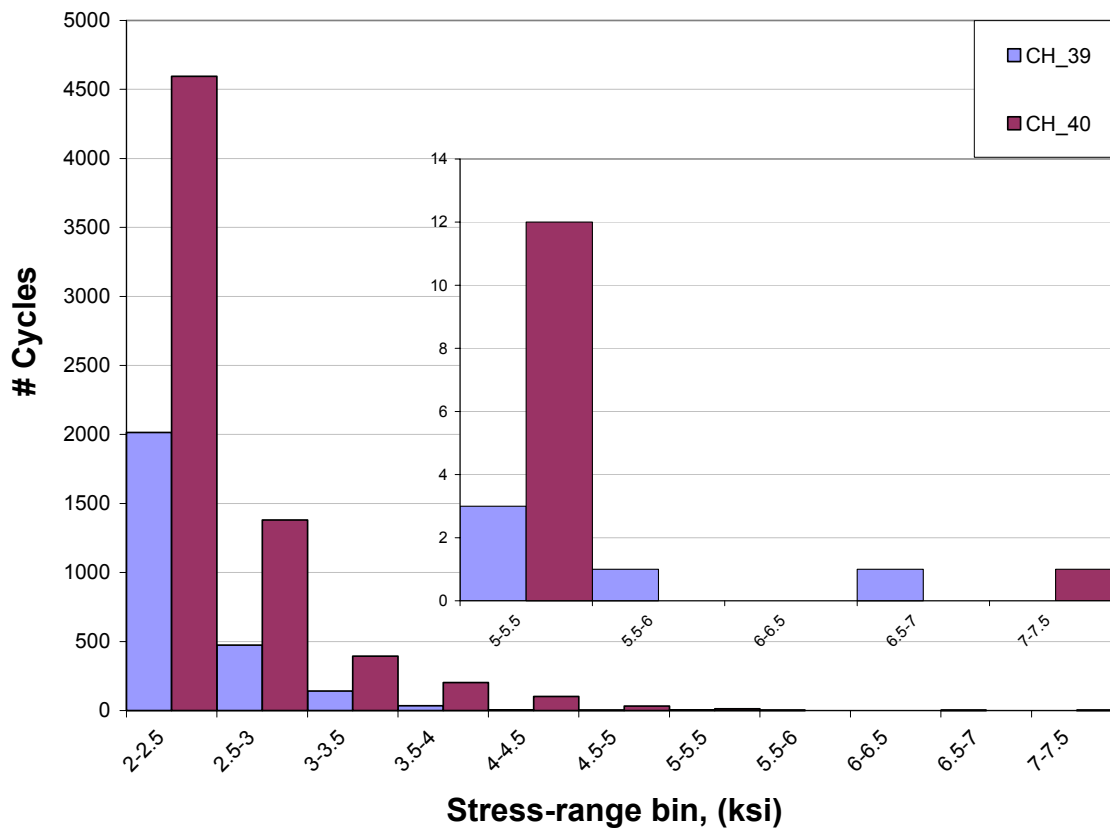
The detail where the gages were installed is classified as Category D detail per AASHTO Specifications with a CAFL of 7 ksi. Figure 6.4 presents the stress-range histogram for strain gages CH_39 and CH_40. The inset in the figure shows that stress-range cycles as high as 7.25 ksi, which is higher than the CAFL of the detail were recorded by strain gage CH_40 during long-term monitoring. The histogram was produced using a lower-bound stress range truncation level of 2.0 ksi, which is approximately 1/4 of the CAFL of the detail. The highest stress-range cycle measured by all strain gages during the monitoring period was 8.75 ksi and was recorded by strain gage CH_12 installed in Span 45. A summary of the fatigue life calculations is presented in Table 6.4. As shown in the table, infinite fatigue life is estimated for all instrumented riveted tie plate details except for the tie plate of Floorbeam 2 in Span 35 and the tie plate of Floorbeam 2 in Span 45. The estimated remaining fatigue life at the north and south edge of the details at these two locations, which was partially calculated using strain gage CH_40 and CH_12, was calculated to be over 100 years.

Figure 6.4 – Stress-range histogram for strain gages CH_39 and CH_40 installed on the south and north edge, respectively, of the tie plate of Floorbeam 2, which crosses transversely over the east girder in Span 35

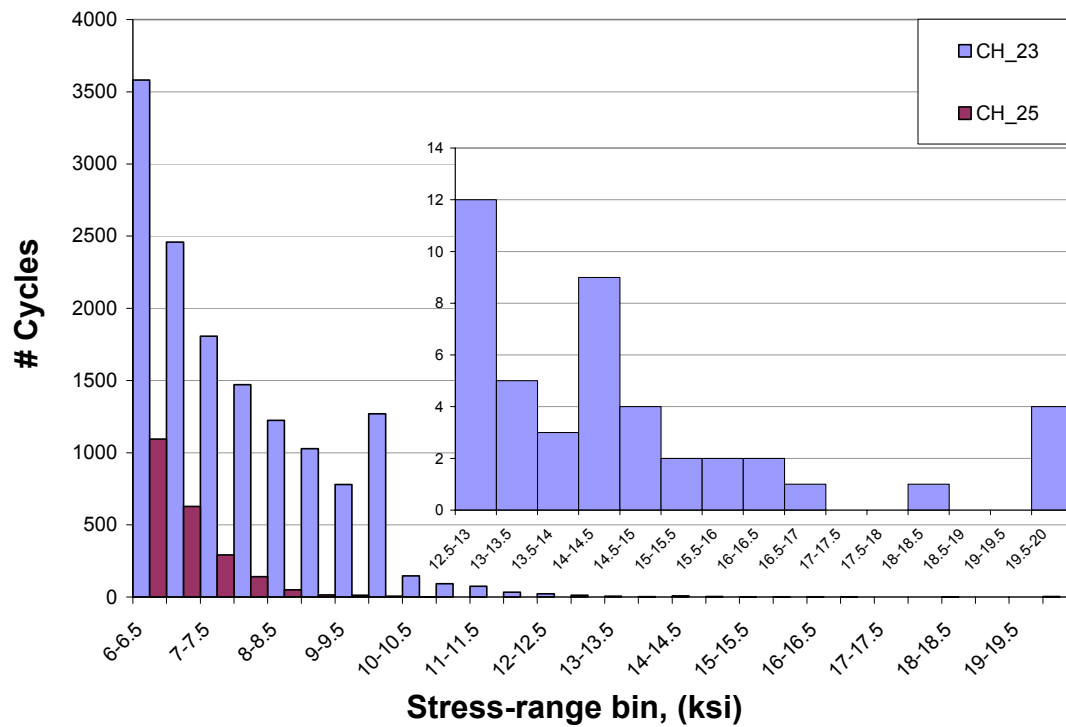
The detail where the gages were installed is classified as Category detail A per AASHTO Specifications with a CAFL of 24 ksi. Figure 6.5 presents the stress-range histogram for strain gages CH_23 and CH_25. The inset in the figure shows that stress-range cycles as high as 19.75 ksi. The histogram was produced using a lower-bound stress range truncation level of 6 ksi, which is approximately $\frac{1}{4}$ of the CAFL of the detail. A summary of the fatigue life calculations is presented in Table 6.5. As shown in the table, infinite fatigue life is estimated for all instrumented cutout details.

Figure 6.5 – Stress-range histogram for strain gages CH_23 and CH_25 installed on the south cutout detail of the east shear connector located at the north end of Span 34

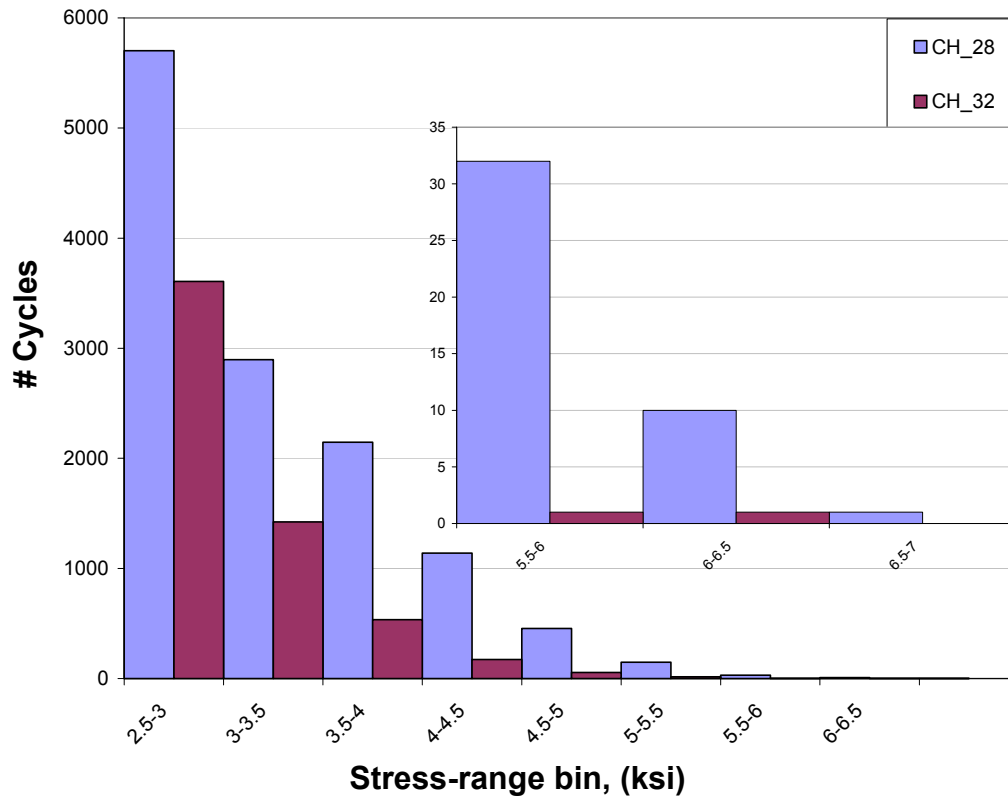
The detail where strain gages CH_28, CH_32, CH_29, and CH_37 are installed is classified as Category C detail per AASHTO Specifications with a CAFL of 10 ksi. Figure 6.6 presents the stress-range histogram for strain gages CH_28 and CH_32 installed transversely on the bottom face of the deck plate in Span 34 and Span 45, respectively. The inset in the figure shows that the highest stress-range cycle recorded is 6.75 ksi in CH_28, which is below the CAFL of the detail. Similarly, Figure 6.7 presents the stress-range histogram for strain gages CH_29 and CH_37 installed longitudinally on the bottom face of the deck plate in Span 34 and Span 45, respectively. The inset in the figure shows that the highest stress-range cycles recorded are 6.75 ksi in CH_29, which is also below the CAFL of the detail. A summary of the fatigue life calculations is presented in Table 6.7. As shown in the table, infinite fatigue life is estimated for all instrumented deck plate details.

Figure 6.6 – Stress-range histogram for strain gages CH_28 and CH_32 installed transversely, in Span 34 and Span 45, respectively on the bottom face of the deck plate at 2 in off-center from the shear connector web near the south end of the north shear connector installed in the span over the east girder
